Par 3 Golf Course Renovation Palm Beach, Florida

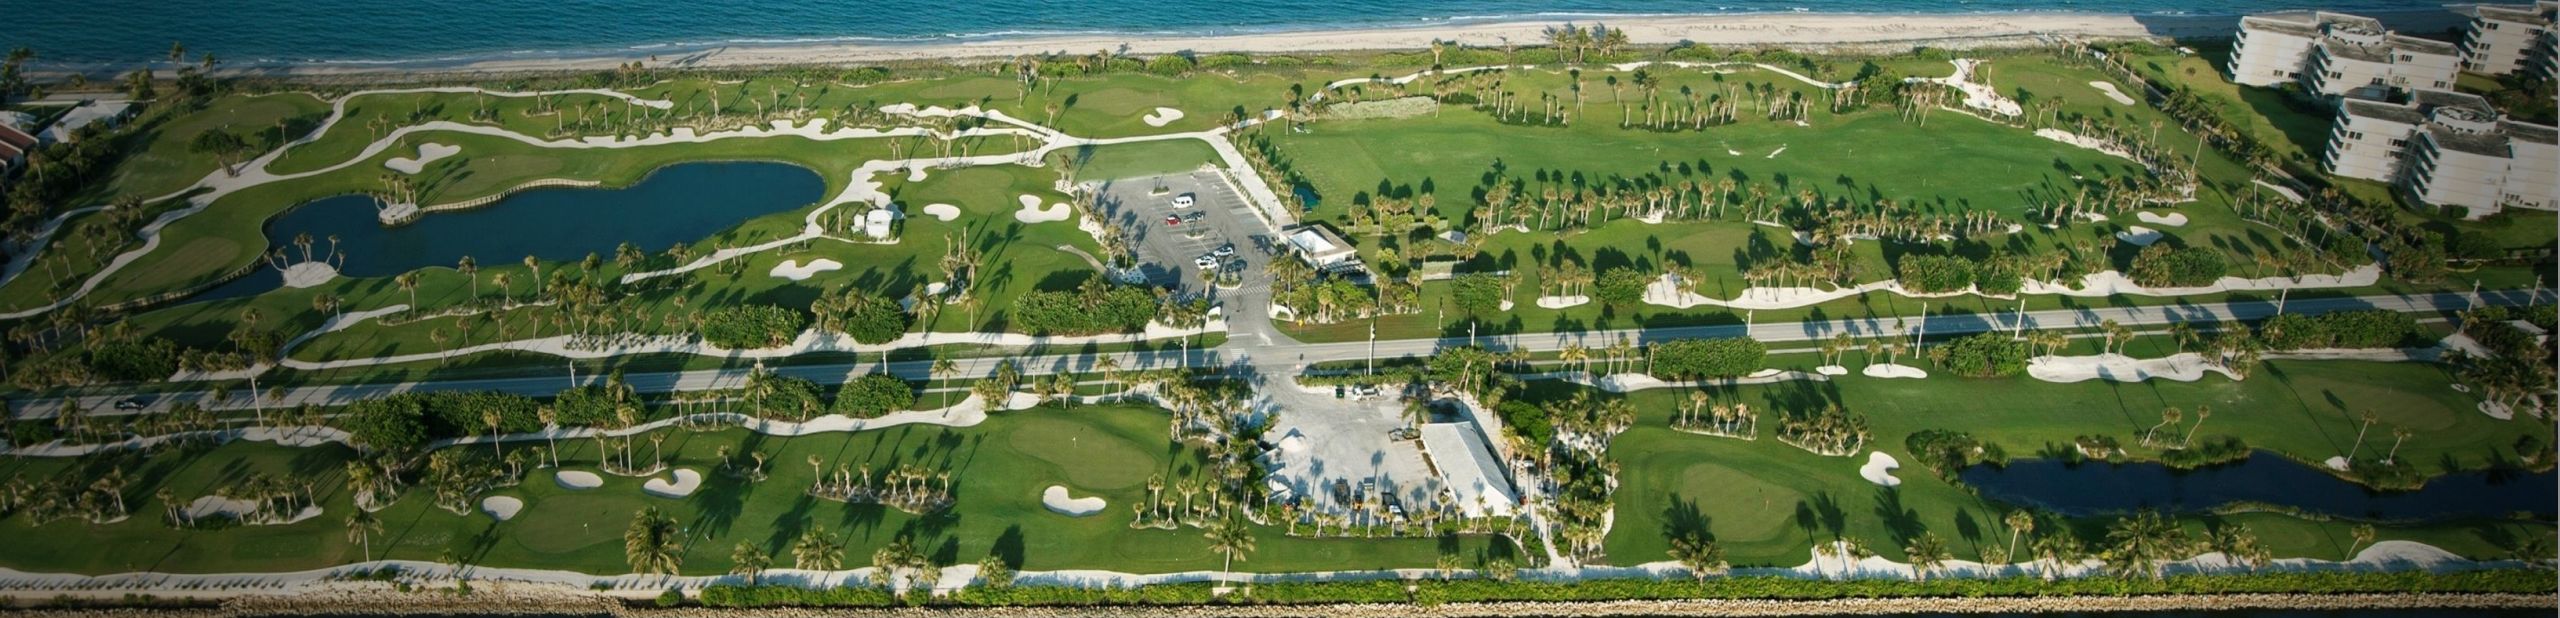
- **Pre-Renovation** →
 - Untreated, nutrient-laden runoff to the adjacent waterway
 - 90,000 gpd of potable water used for irrigation
 - Flooding throughout the site
- **Key Design Features** →
 - Paspalum sod - extremely drought and salt tolerant
 - Native, drought, and salt tolerant vegetation
 - Irrigation with a blend of pumped brackish water and stormwater
 - All stormwater is collected and treated
 - Stormwater injection wells for large storm events
 - Brackish water from the Floridan Aquifer under artesian pressure
- **Results** →
 - Eliminated the use of 90,000 gpd of potable water
 - Reduced stormwater runoff by 24%
 - Reduced phosphorus discharges by 52%
 - Millions of gallons of stormwater used for irrigation
